Monitoring Data RecordProject Title: US 70 in Salisbury (R-2911E) COE Action ID: 200221536Stream Name: Setman Branch DWQ Number: 030908City, County and other Location Information: Salisbury, Rowan Co., Sta. 8+35 to Sta. 8+85Date Construction Completed: Water was turned and streambank reforestation was completed in March 2006.

Monitoring Year: ( 1 ) of 5

# Setman Branch

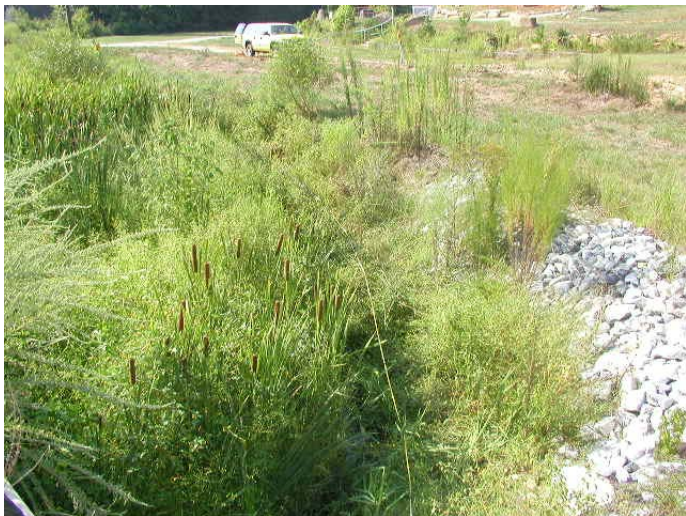
PP #1 Looking downstream from box culvert

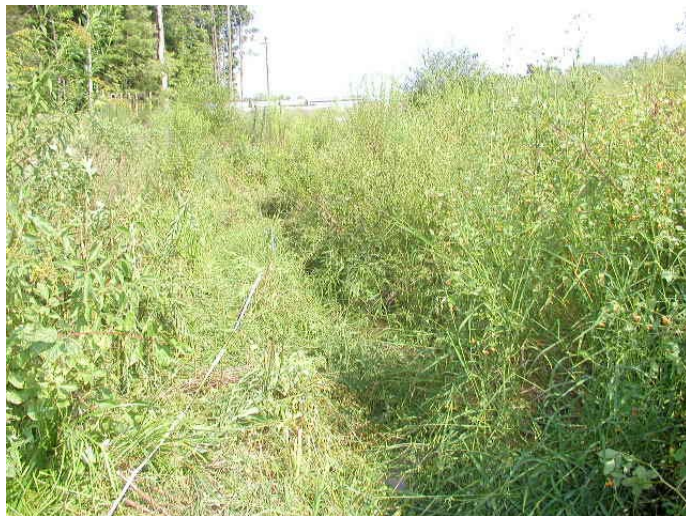
PP #2 Upstream

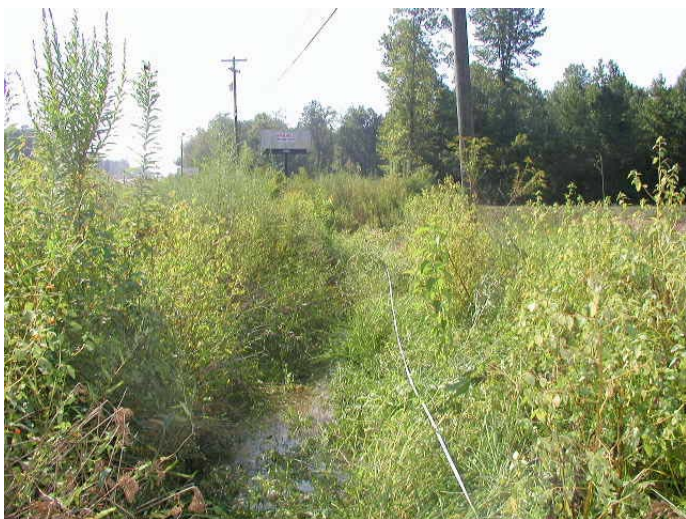
PP #3 Downstream

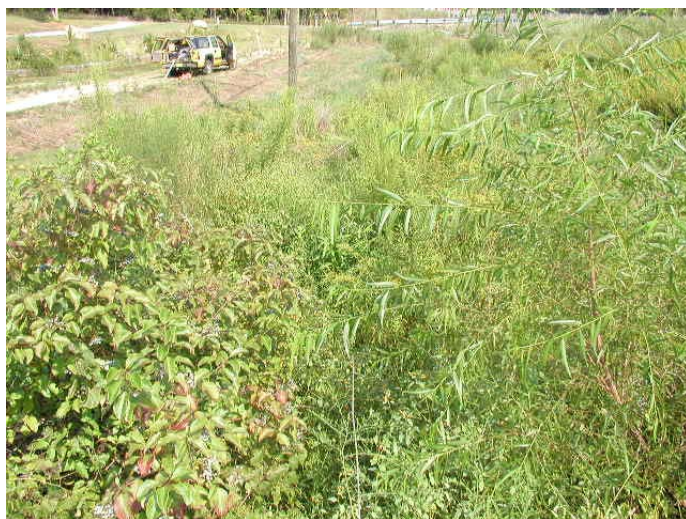
PP # 4 Looking upstream from driveway pipe
